COMBAT DAMAGE ASSESSMENT TEAM
A-10/GAU-8 LOW ANGLE FIRINGS
VERSUS
INDIVIDUAL SOVIET TANKS
(February - March 1978)

R.H.S. Stolfi

August 1979

COMBAT DAMAGE ASSESSMENT COMMITTEE (CDAC) REPORT

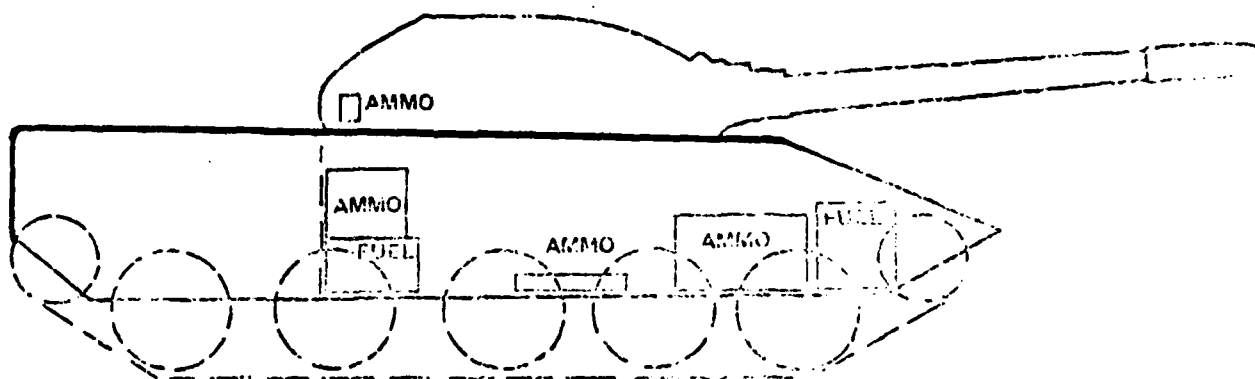
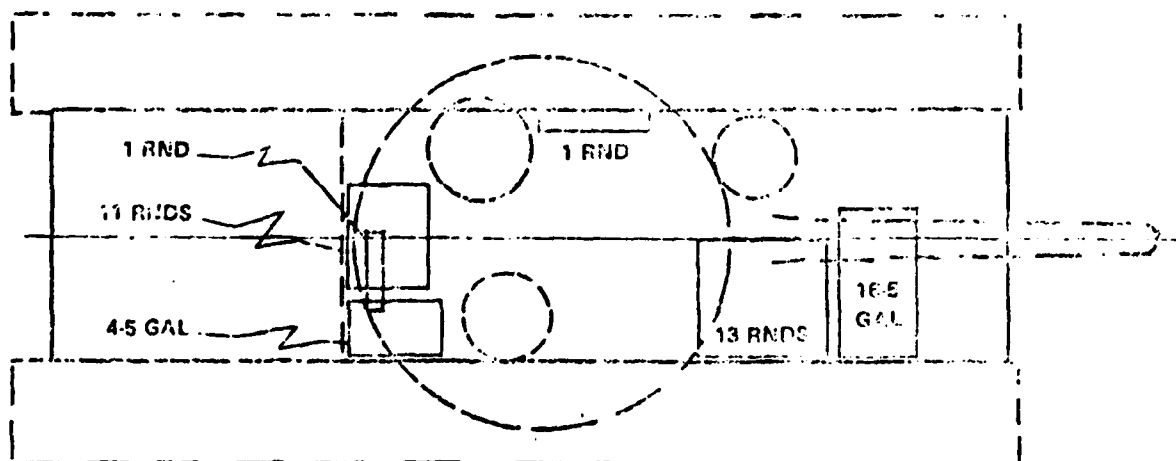
AMMUNITION: U.S. 90-MM TP-7
 FUEL: D-2 DIESEL IN 3/11 FULL 5 GAL GALS

Fig 2. Locations of Fuel and Ammunition in Target Tanks

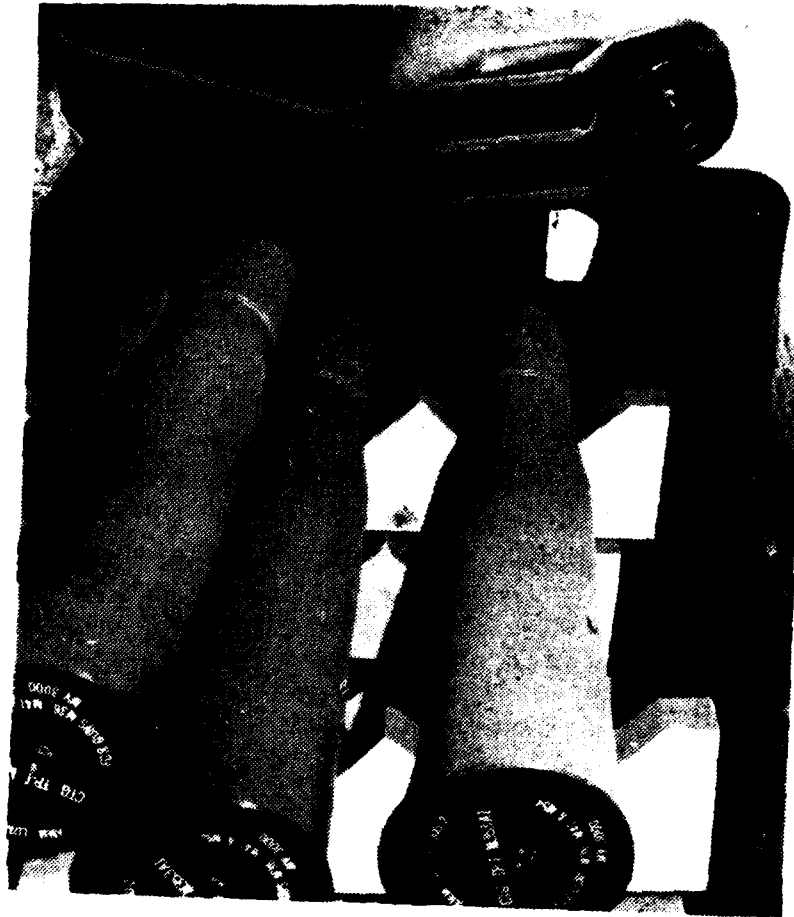
Fig 3. Simulated Bow Racks and Fuel Tank

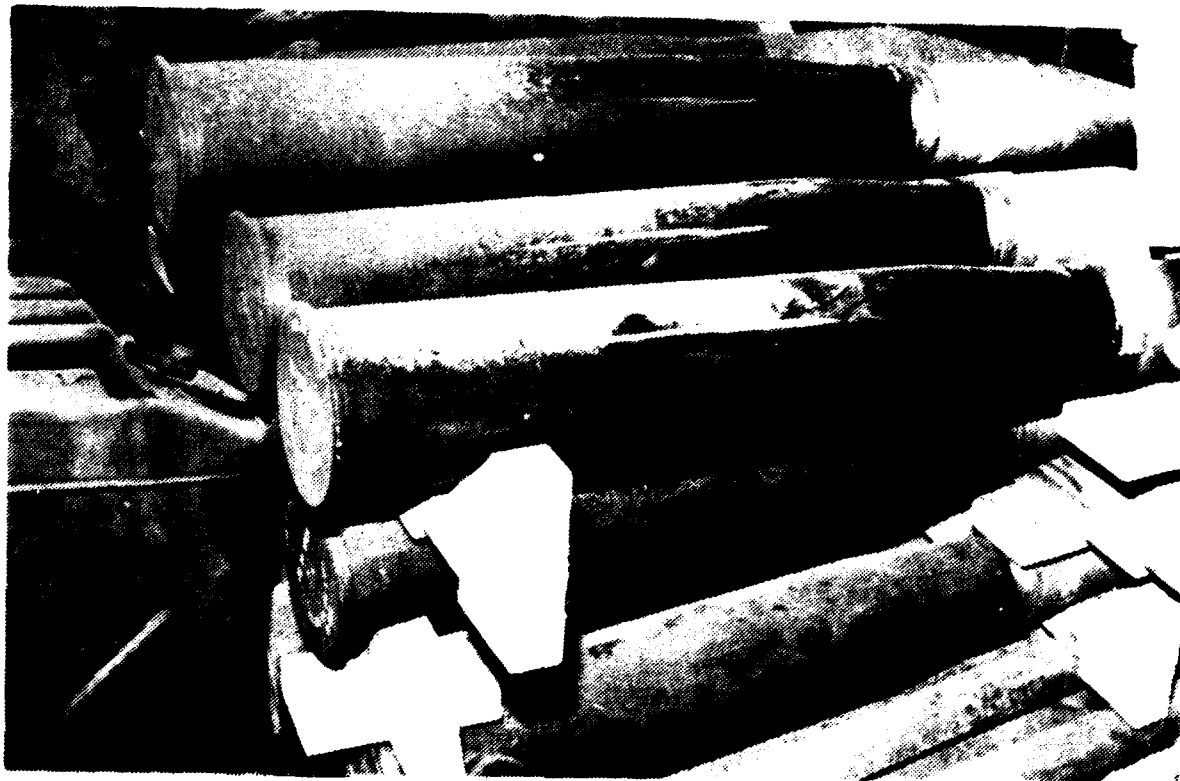
Fig 4. Simulated Fuel Tank and Rear Fighting Compartment Ammunition Stowage

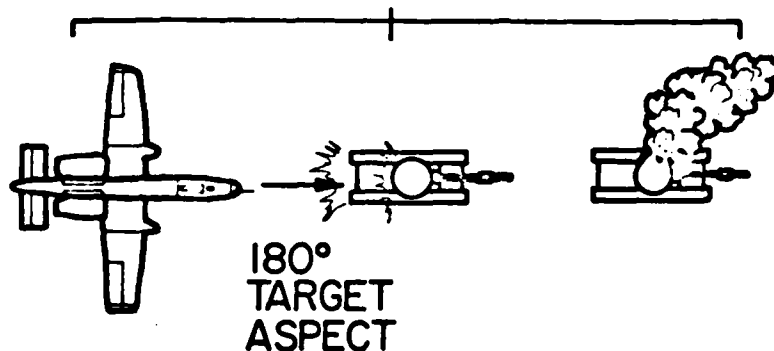
ILLUSTRATION 1

A-10/GAU-8 LOW ANGLE FIRINGS
VERSUS INDIVIDUAL SOVIET TANKS
(MISSION 1, PASS 1 VS TANK 13)
(17 FEB 78)

- K-KILL
- INTERNAL
EXPLOSIONS
AND FIRE
- RESULTING
FROM SINGLE
REAR TURRET
PERFORATION

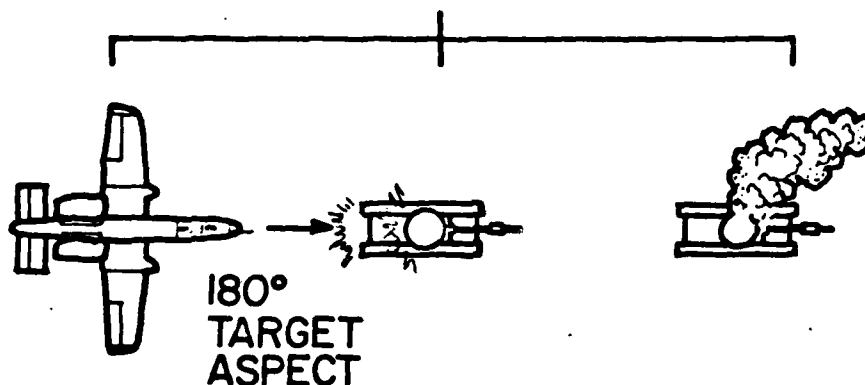
ILLUSTRATION 2

A-10/GAU-8 LOW ANGLE FIRINGS
VERSUS INDIVIDUAL SOVIET TANKS
(MISSION 2, PASS 1 VS TANK 13)
(24 FEB 78)

- 348 KNOTS
- 23° DIVE ANGLE
- 4402 FT. OPEN FIRE
- 3055 FT. CEASE FIRE
- 144 RDS FIRED

- K - KILL
- INTERNAL EXPLOSIONS AND FIRE
- RESULTING FROM SINGLE REAR TURRET PERFORATION

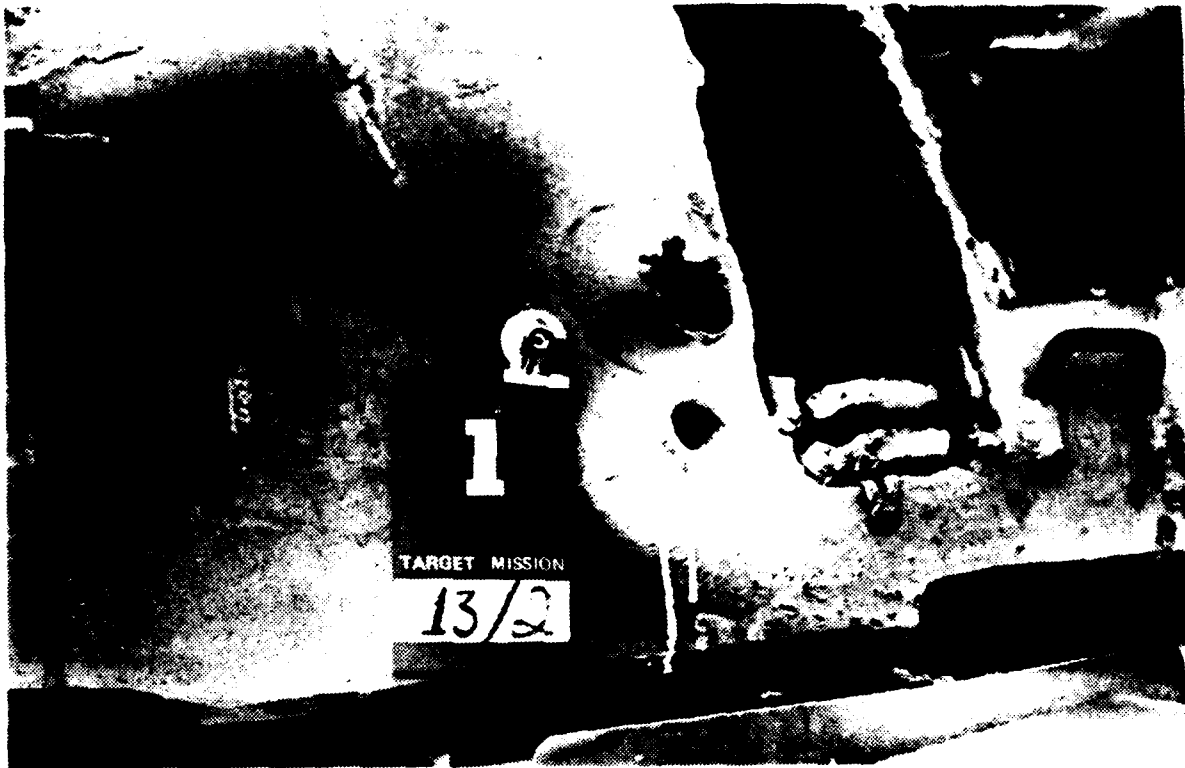
This target was assessed as an immediate K-Kill, resulting from a single perforation of the rear turret armor (Fig. 7). The most likely cause of the kill was an internal explosion which occurred approximately .62 seconds into the burst, probably occasioned by perforation of the armor from impact 1, which occurred .29 seconds into the burst. The location of the strike indicates that the most probable cause of the explosion was impact of the penetrating projectile, or spall fragments, into a single round of ammunition stowed in the rear of the turret (see Fig. 2). The armored envelope of this target was perforated by two other projectiles, impact 5 (Fig. 8) and impact 6 (Fig. 9).

Fig 7. Location of Strike, Impact 1, Mission 2, Target 13

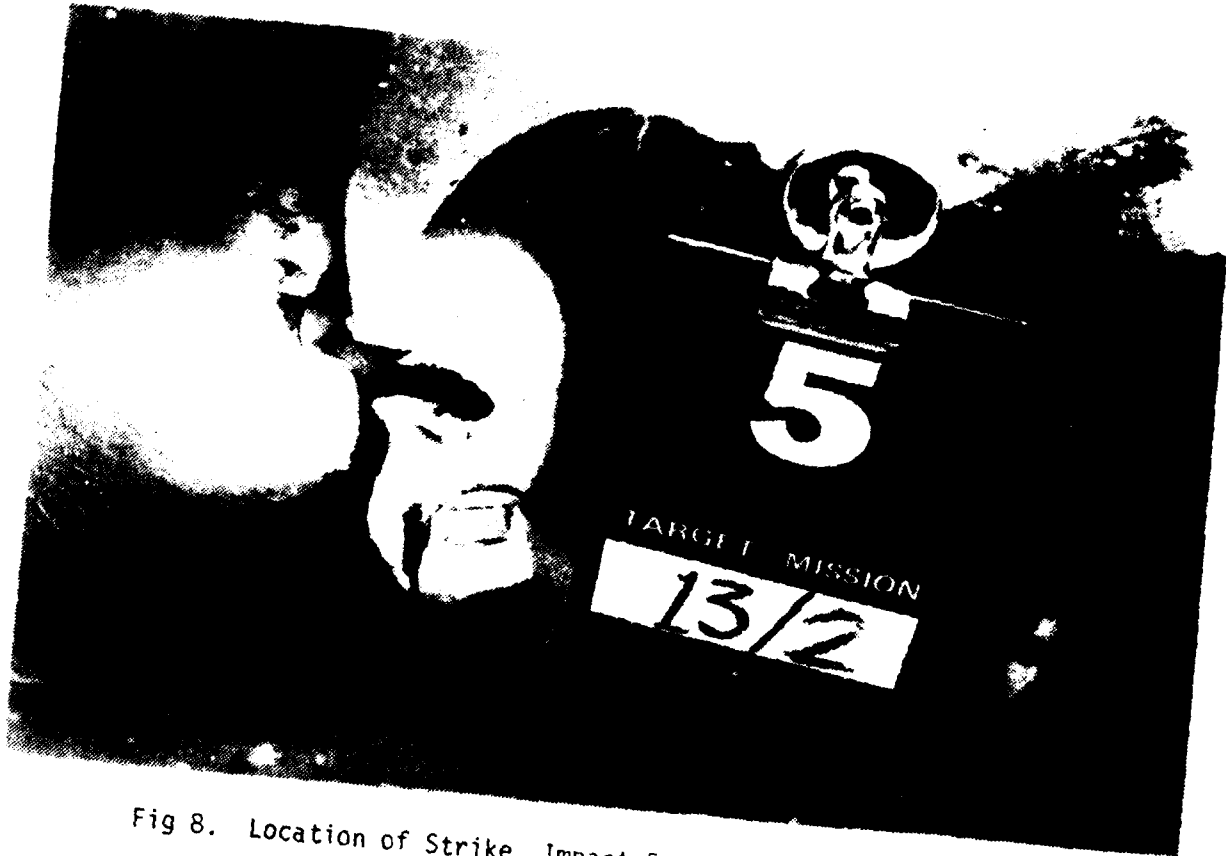
Fig 8. Location of Strike, Impact 5, Mission 2, Target 13

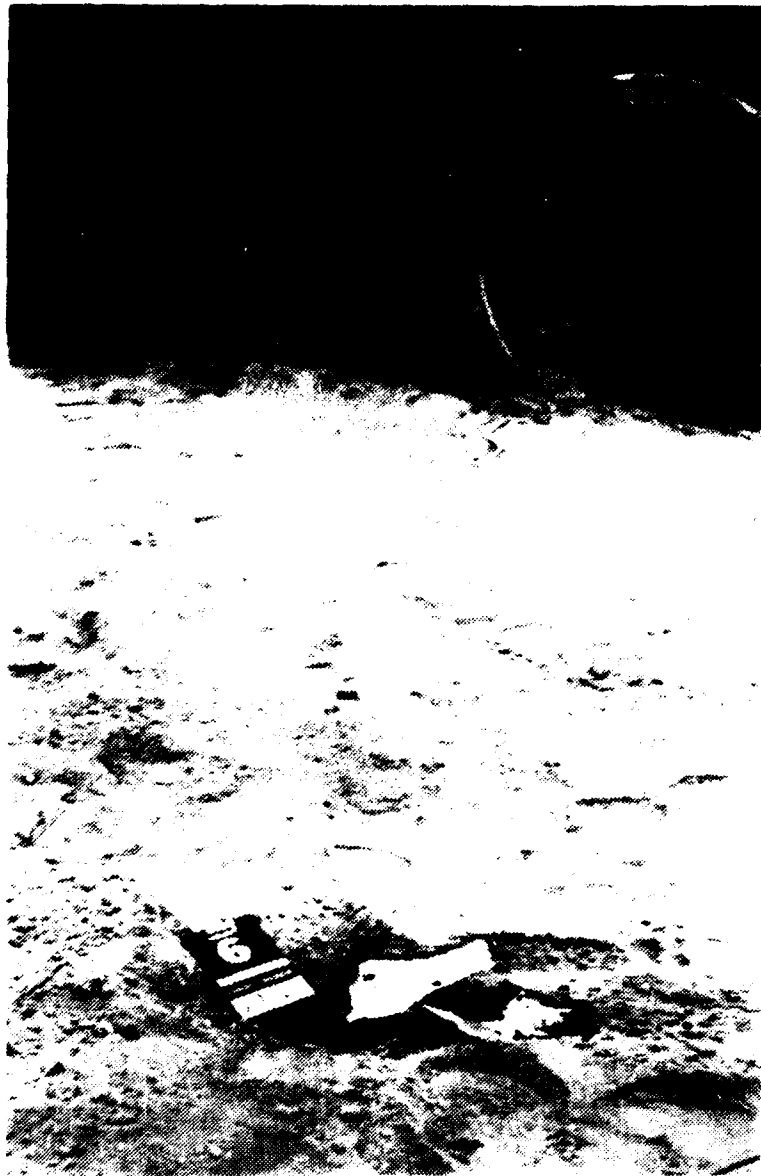
Fig 11. Location of Honeycomb Patch Dislodged by Impact 6

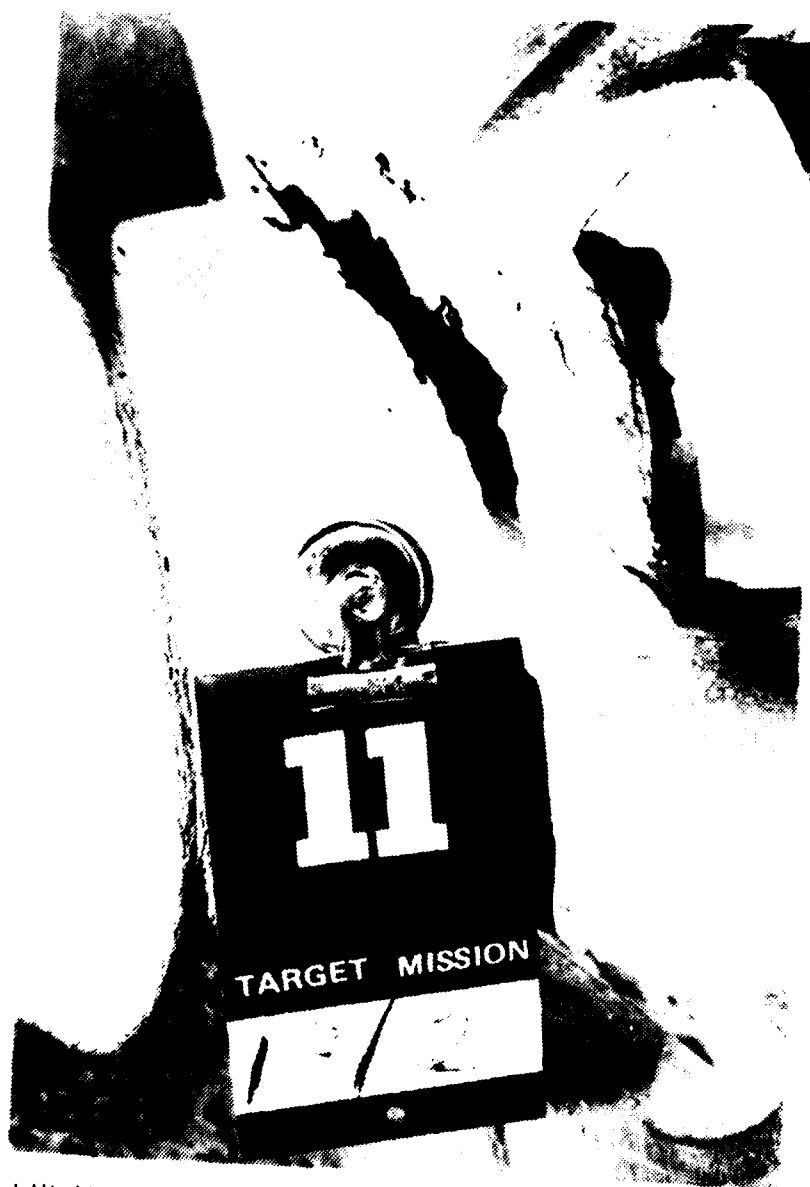
Significant damage was caused by one additional impact (Impact 11, Fig. 12) which penetrated into the right track drive sprocket, cracking the hub and causing loss of oil and severe damage to the bearings. In the absence of a K-Kill, this damage alone was sufficient to cause a 100 percent mobility kill. However, the reader should be cautioned that the track, which would have shielded the sprocket from this impact, was not in place. If it had been, different results may have been recorded.

Fig 12. Damage to Right Track Drive Sprocket
Caused by Impact 11 (Mission 2, Target 13)

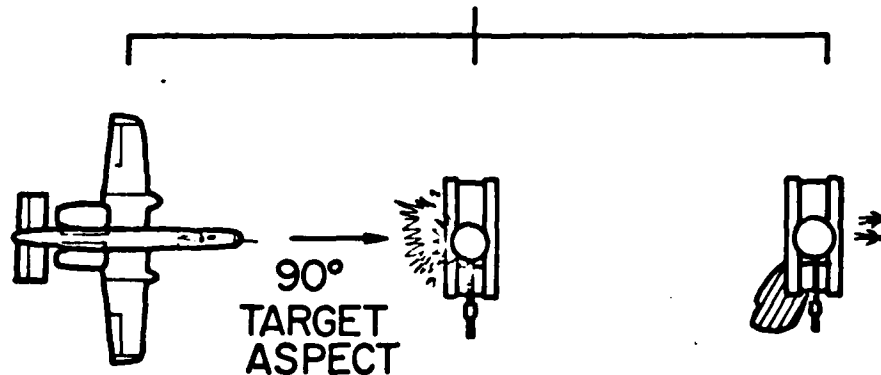
ILLUSTRATION 3

A-10/GAU-8 LOW ANGLE FIRINGS
VERSUS INDIVIDUAL SOVIET TANKS
(MISSION 2, PASS 2 VS TANK 18)
(24 FEB 78)

- 340 KNOTS
- 1.83° DIVE ANGLE
- 3502 FT OPEN FIRE
- 2382 FT CEASE FIRE
- 144 RDS FIRED

- 100% M-KILL
- 0.95 % F-KILL
- RESULTING
FROM GUNNER
KIA TC WIA
AND FUEL TANK
DAMAGE

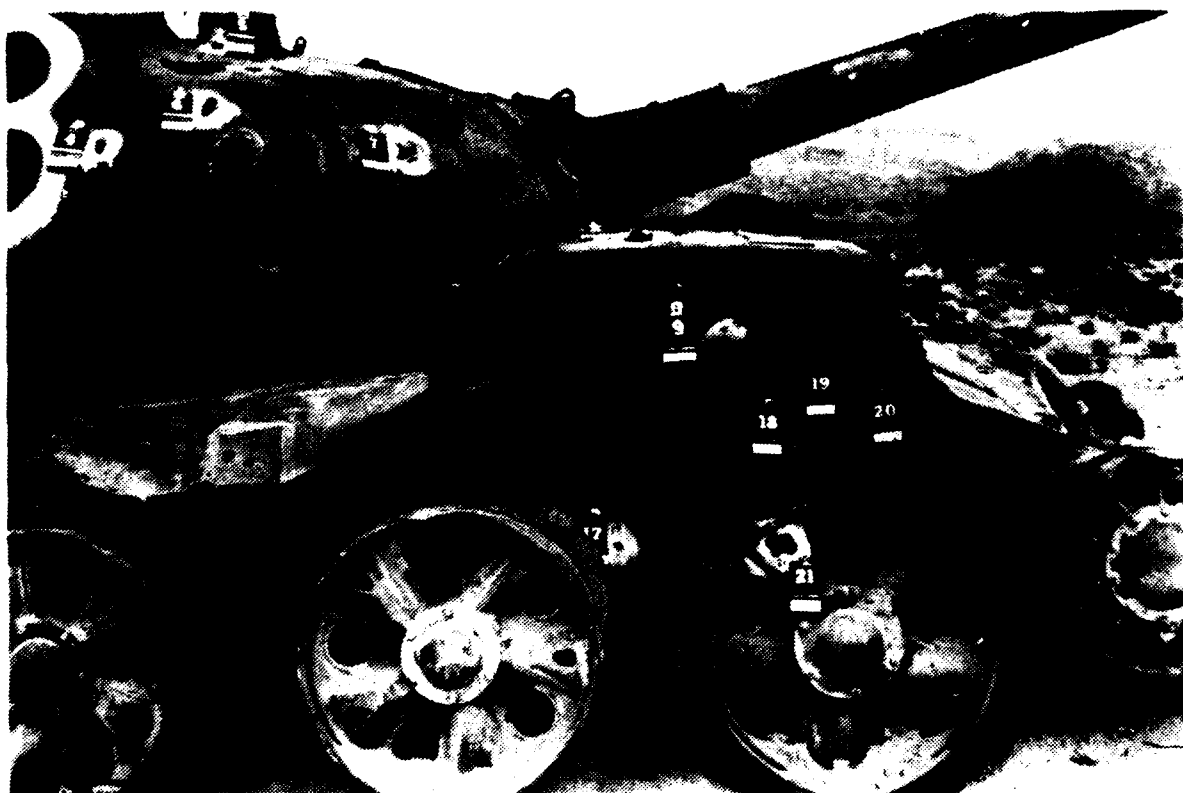
This target was impacted by 21 projectiles of which four caused significant damage. These impacts (numbers 5, 8, 9 and 17) are shown in Fig. 13.

Fig 13. Location of Significant Impacts, Mission 2, Target 18

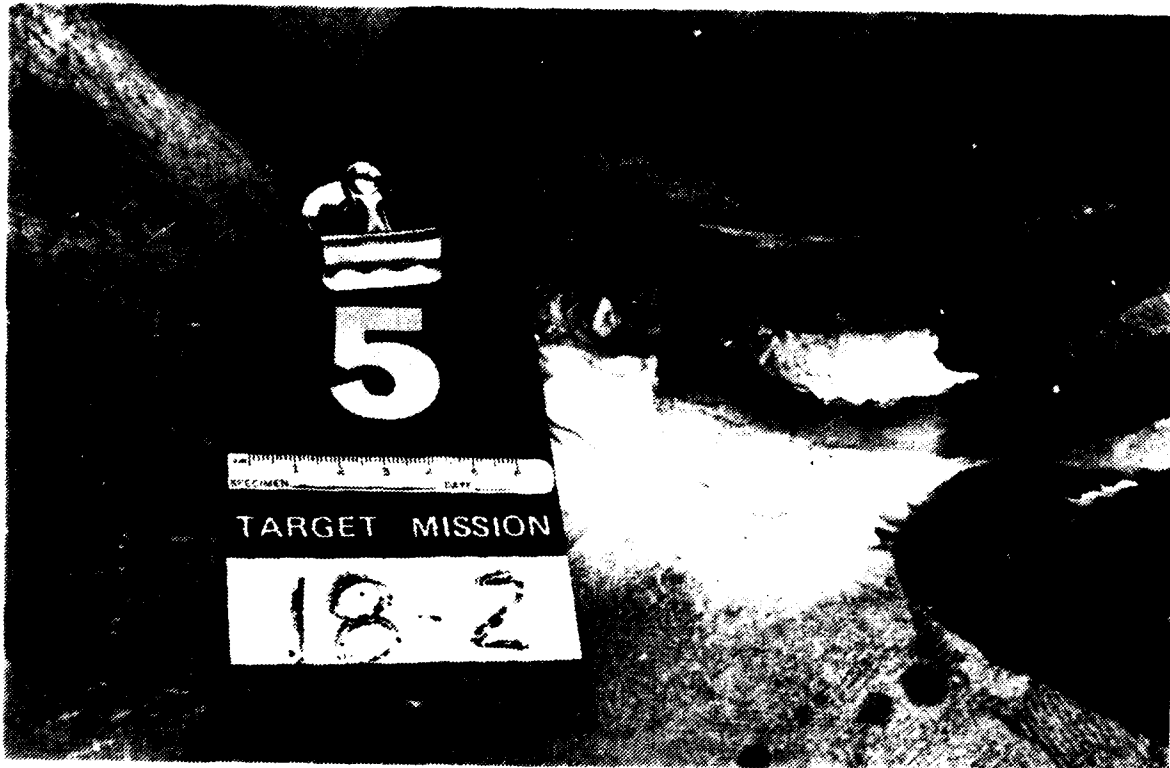
Impact number five perforated the loader's periscope housing (Fig. 14). The projectile and/or spall fragments continued through the fighting compartment to the opposite side of the turret and damaged two mannikins representing the gunner and tank commander. The mannikin at the gunner's station received projectile and/or spall damage in the left shoulder area, and to the right side of the head as shown in Fig. 15 and was assessed as killed in action (KIA). The mannikin representing the tank commander (Fig. 16) was damaged in the left shoulder area and was assessed as wounded in action (WIA). Based on these two casualties, an F-Kill of 95 percent was assessed.

Fig 14. Close-up View of Perforation Through Loader's Periscope Housing, Mission 2, Target 18

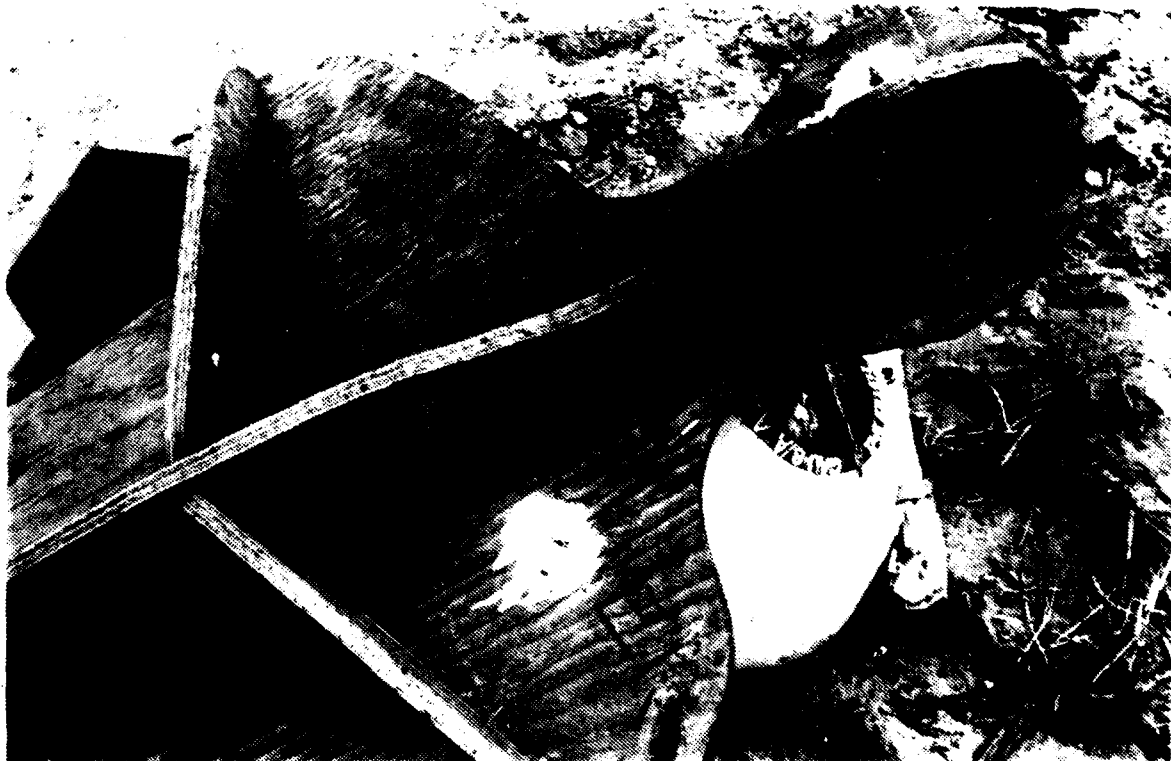
Fig 15. Projectile and/or Spall Damage to Mannikin
at Gunner's Station (Impact 5, Mission 2,
Target 18)

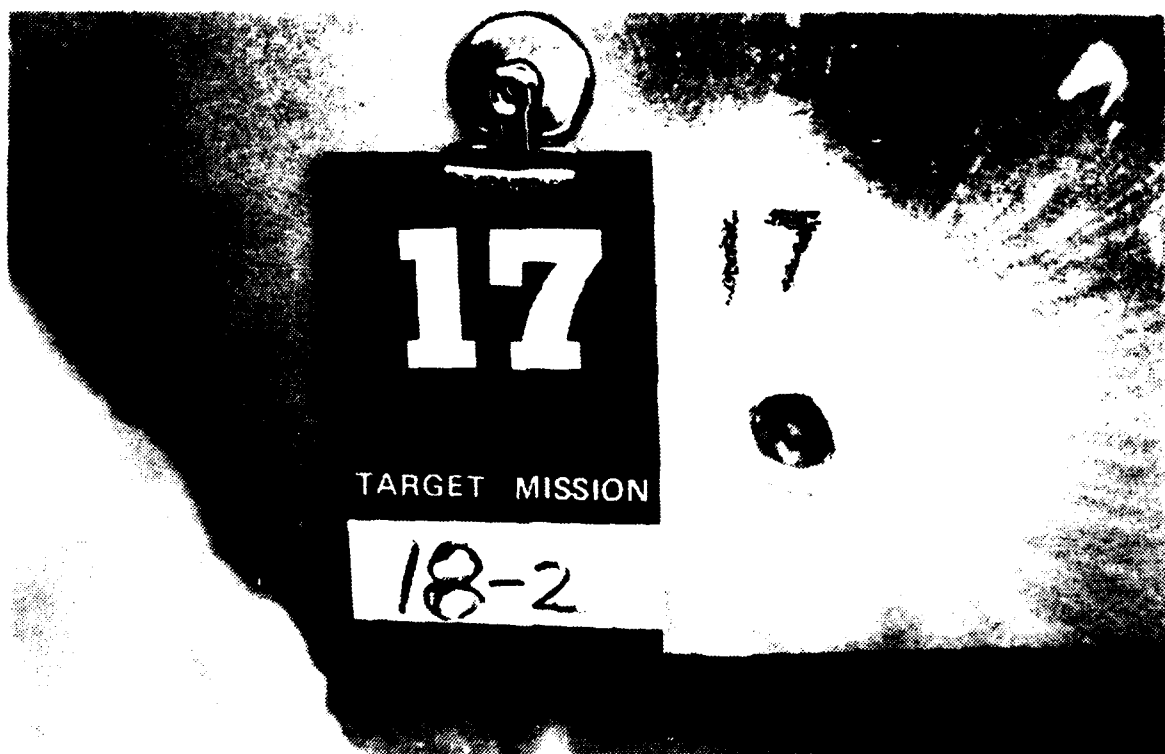
Impact 17 (Fig. 17) perforated the right front side hull armor immediately in front of the number 2 road wheel and ruptured five of the 16 five-gallon fuel cans simulating the bow fuel tank. Figs. 18 through 22 show spall fragment perforations in the fuel cans. A mobility kill was assessed based on a judgment by the CDAT that a ruptured bow fuel tank, together with two crew casualties, would render the tank ineffective for combat. The tank was accorded the capability of moving a short distance to a covered and/or concealed position, or to a maintenance area, for repairs.

Fig 17. Perforation of Right Side Hull Armor
(Part of Projectile Remains in Hole),
Mission 2, Target 18

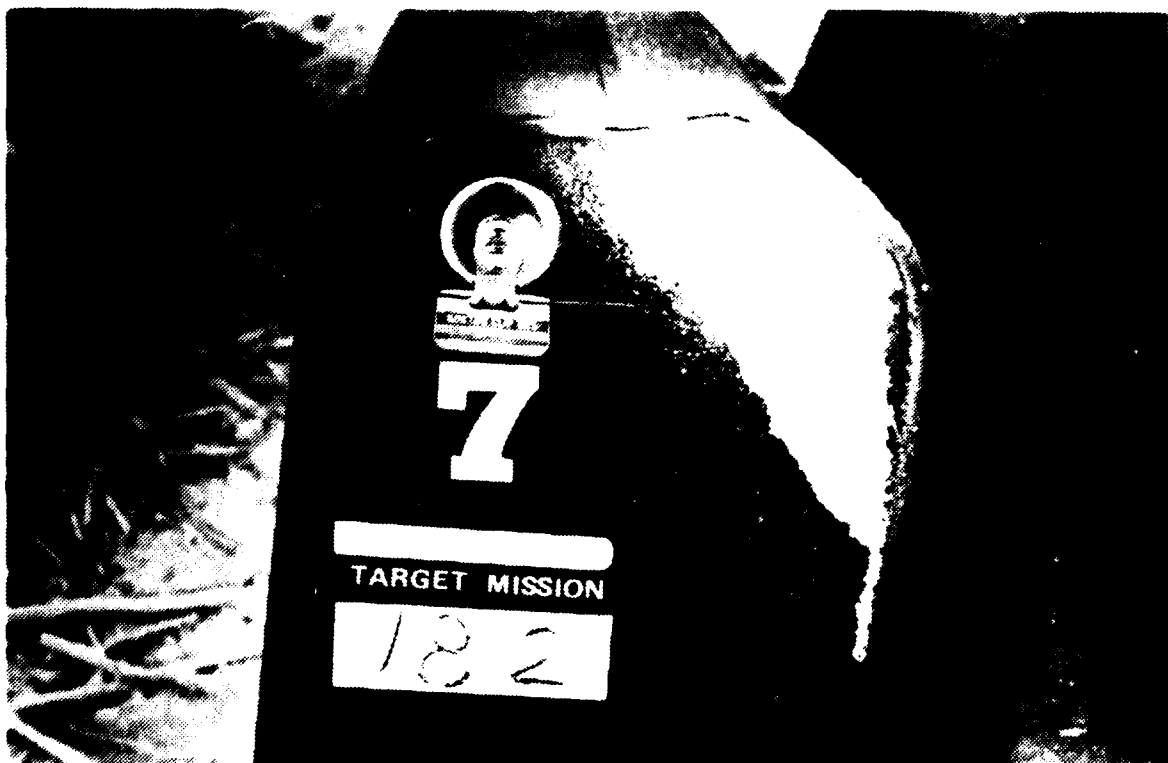
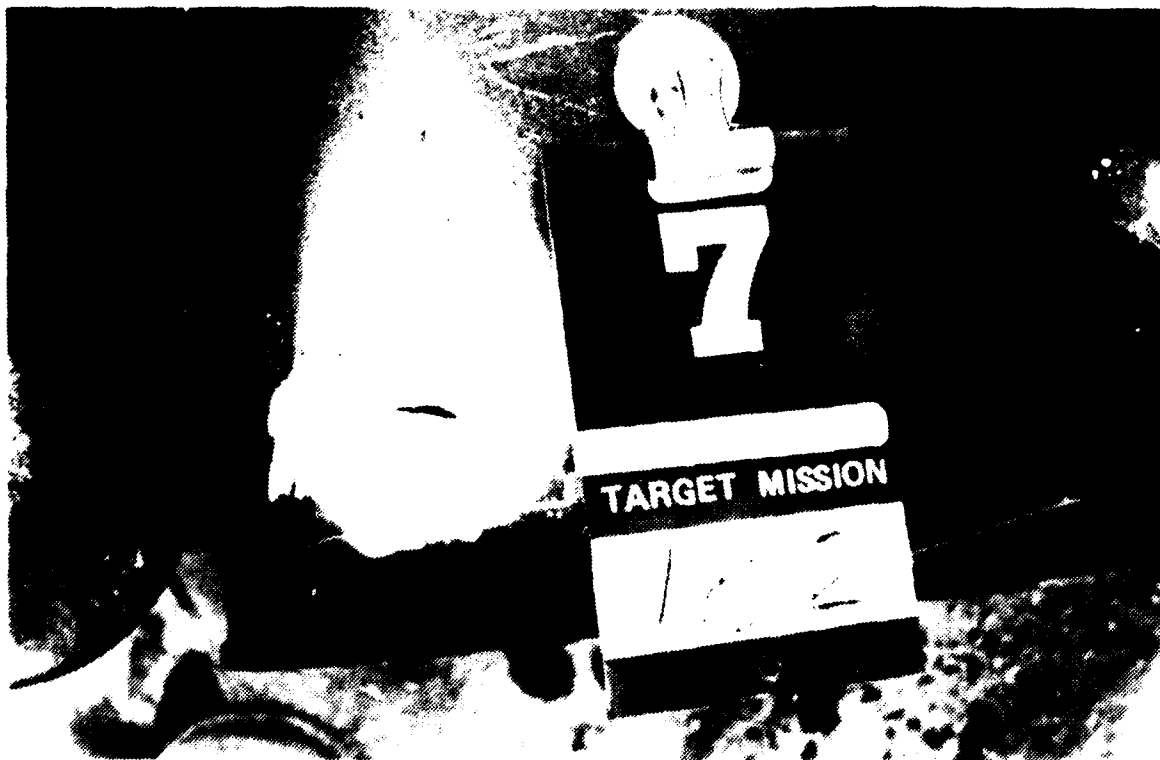
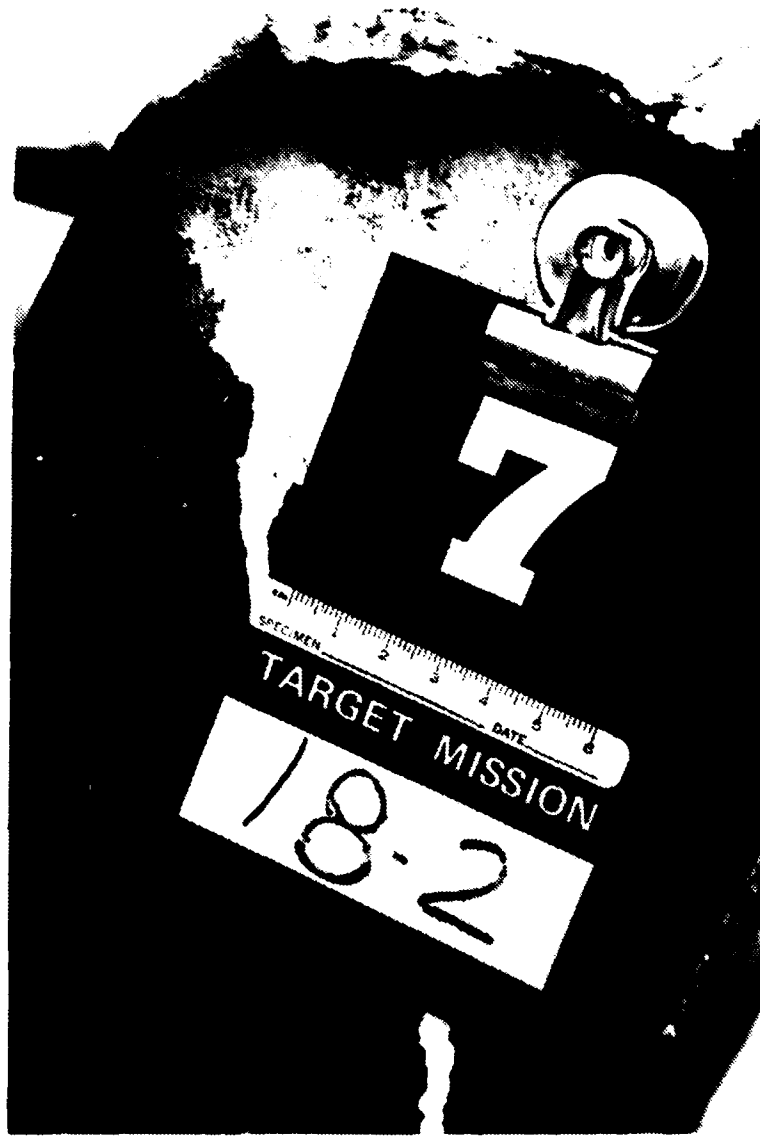
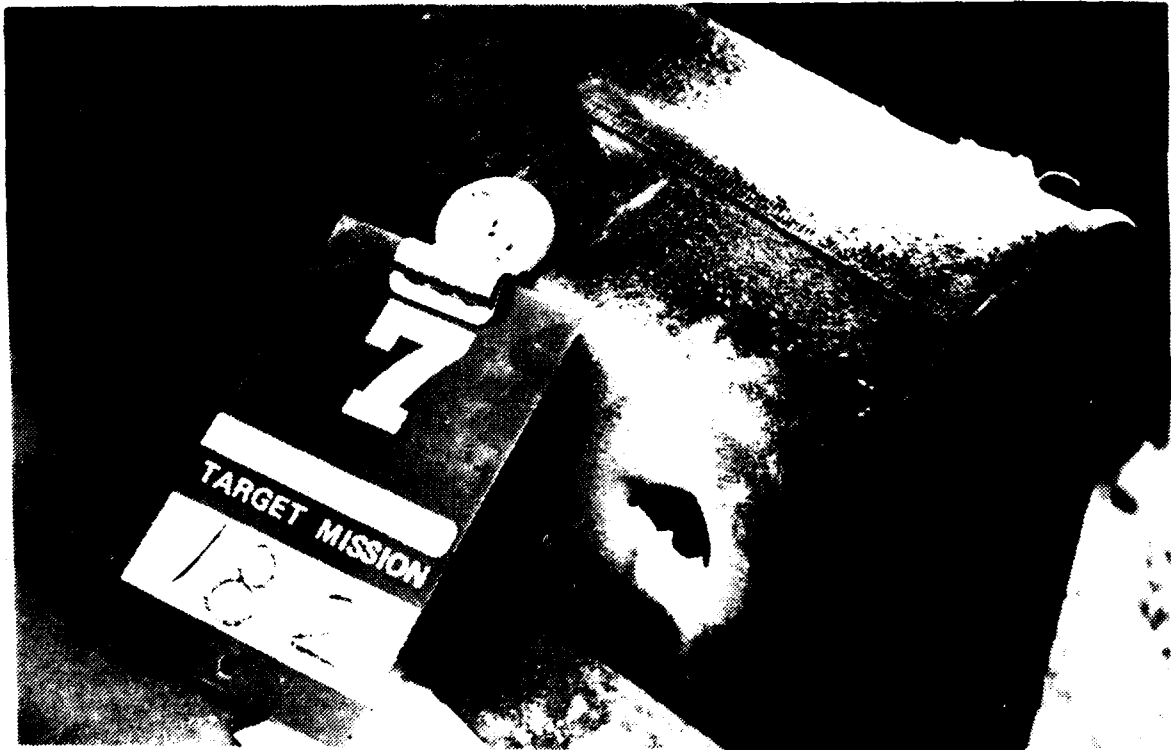
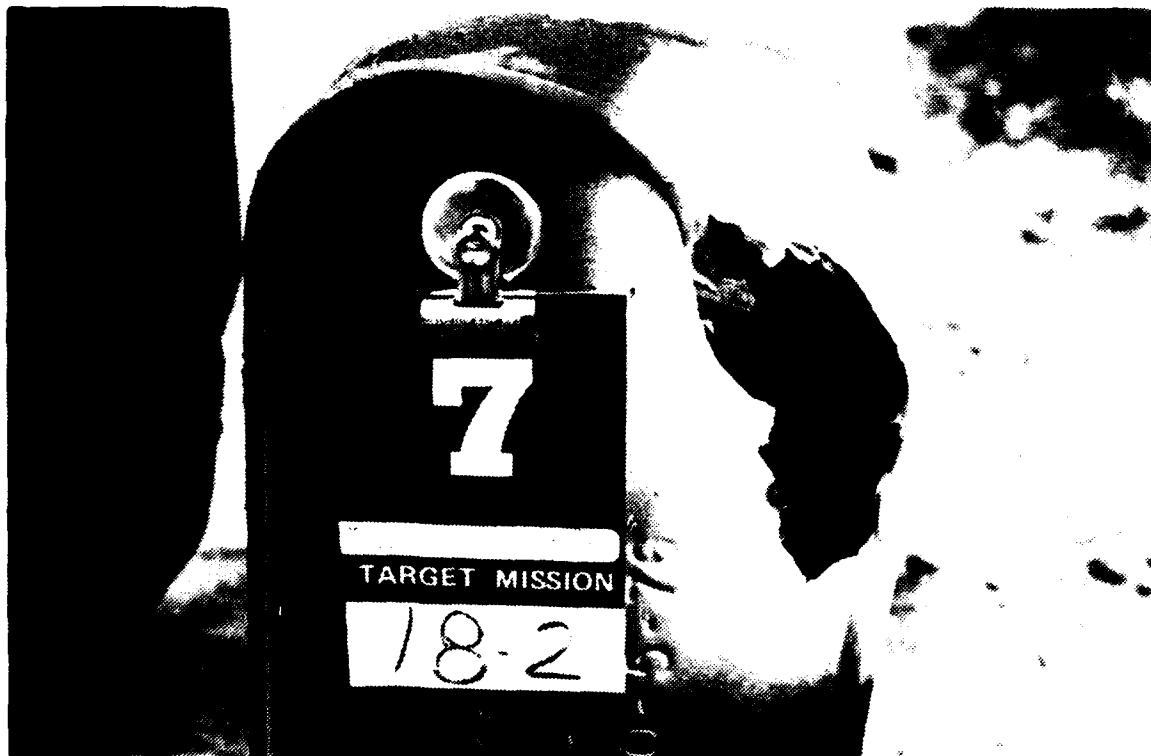
Fig 18. Perforation of Fuel Can Simulating
Bow Fuel Tank, Impact 17, Mission 2,
Target 18 (NOTE: This impact is mis-
numbered and should read 17.)

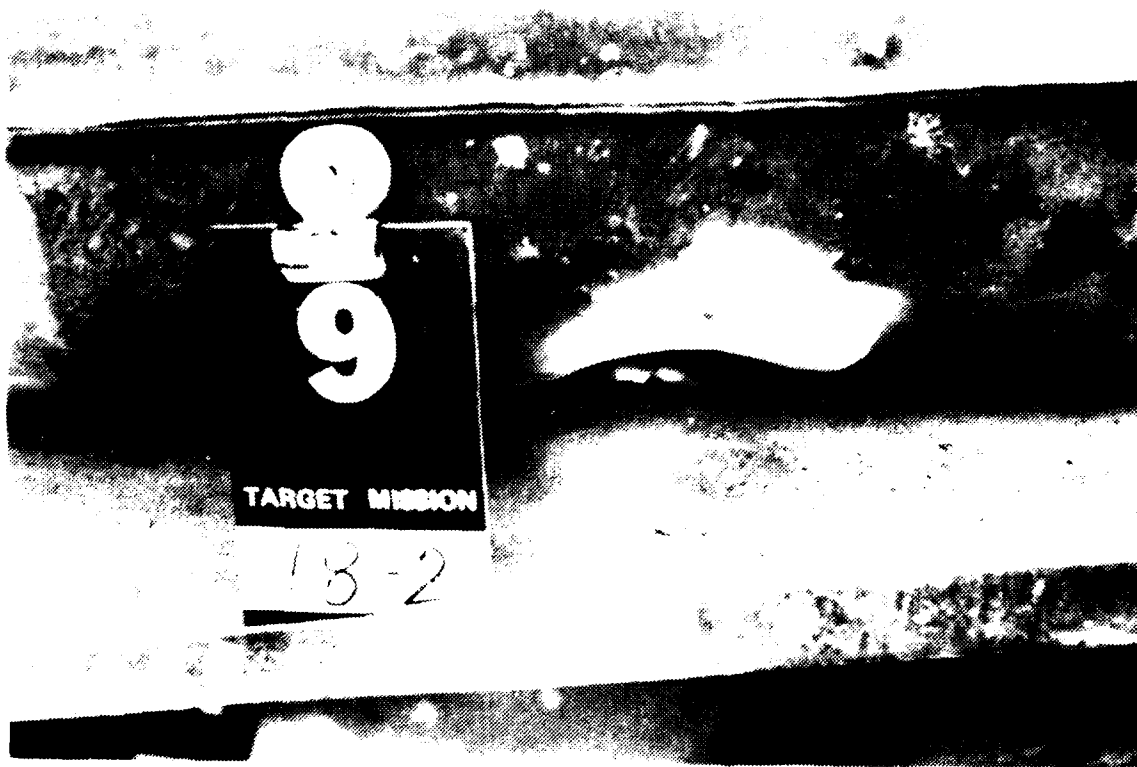
Fig 24. Perforation of External Fuel Tank
by Impact 9, Mission 2, Target 18

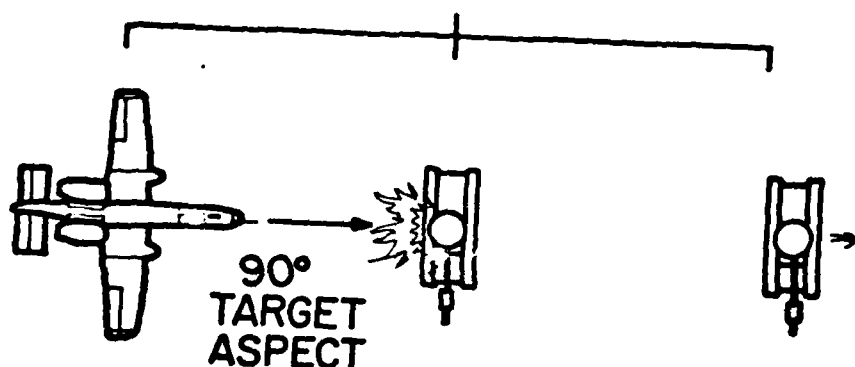
ILLUSTRATION 4
A-10/GAU-8 LOW ANGLE FIRINGS
VERSUS INDIVIDUAL SOVIET TANKS
(MISSION 3, PASS 1 VS TANK 18)
(2 MARCH 78)

- 377 KNOTS
- 4.41° DIVE ANGLE
- 3735 FT. OPEN FIRE
- 2616 FT. CEASE FIRE
- 120 RDS FIRED

- 100% M-KILL
- 60% F-KILL
- RESULTING FROM
TANK CDR VIA
GUN TUBE PERF
AND SUSPENSION
DAMAGE

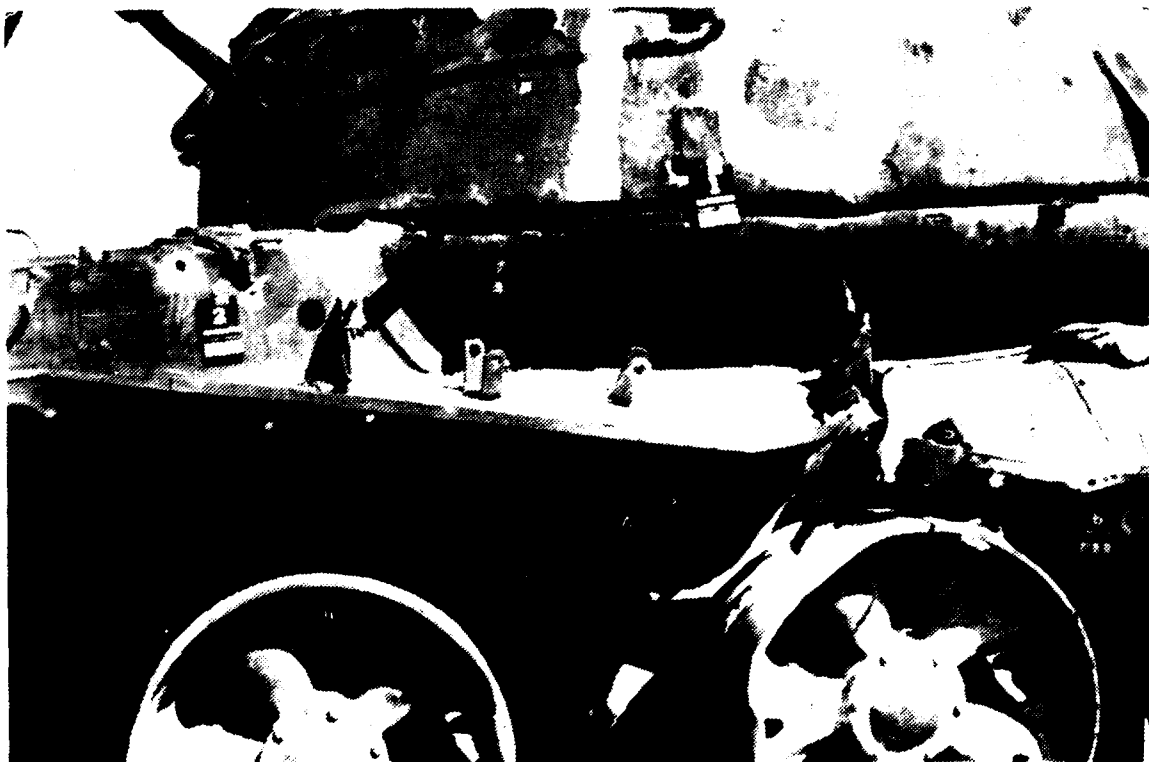
Impact 2 (Fig. 25) perforated the right side hull armor just above the number four road wheel. Projectile and/or spall fragments damaged the left hand and thigh area of the mannequin at the tank commander's station (Fig. 26), a round of ammunition in the fighting compartment stowage area (Fig. 27), and a round of ammunition in the bow storage area (Fig. 28). The tank commander was assessed a casualty (WIA) and a 50 percent F-Kill assigned. No contribution to the kill was assessed due to the fragment damaged ammunition; however, the damage was interesting because it was the widest distribution of fairly large fragments noted in this series of tests.

Fig 25. Location of Strike, Impact 2, Mission 3,
Target 18

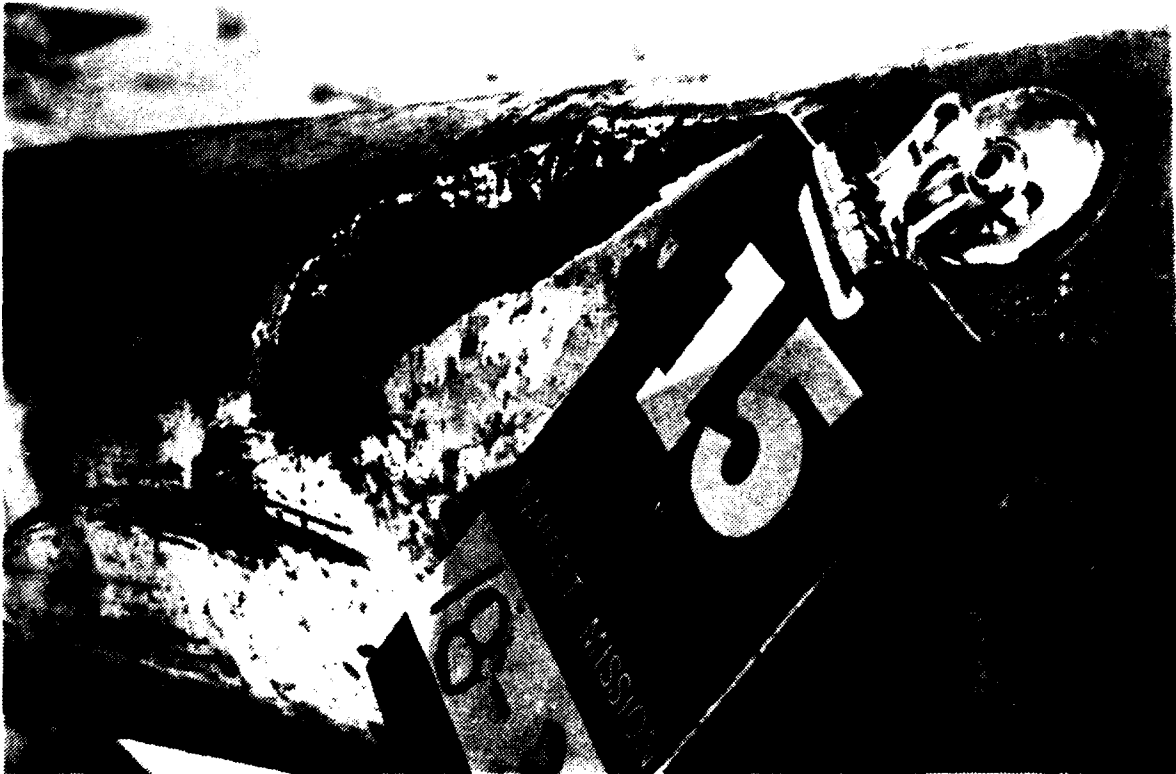
Impact 15 (Fig. 29) penetrated one wall of the gun tube and was assessed as a 10 percent contribution to the F-Kill. This assessment was based on tactical considerations and the CDAT's perceptions of crew attitudes based on damage to the gun tube alone. It was the CDAT's judgment that the crew would avoid firing chemical energy type rounds such as high explosive anti-tank munitions (HEAT) due to the possibility of premature functioning of the projectile due to gun tube damage. However, it was also considered that during an active engagement against ground targets dangerous to tanks they could and probably would continue to fire kinetic energy (armor piercing) rounds with some loss in accuracy and range which could be compensated for to some extent by gunnery techniques.

Fig 29. Penetrated Wall of Gun Tube
Impact 15, Mission 3, Target 18

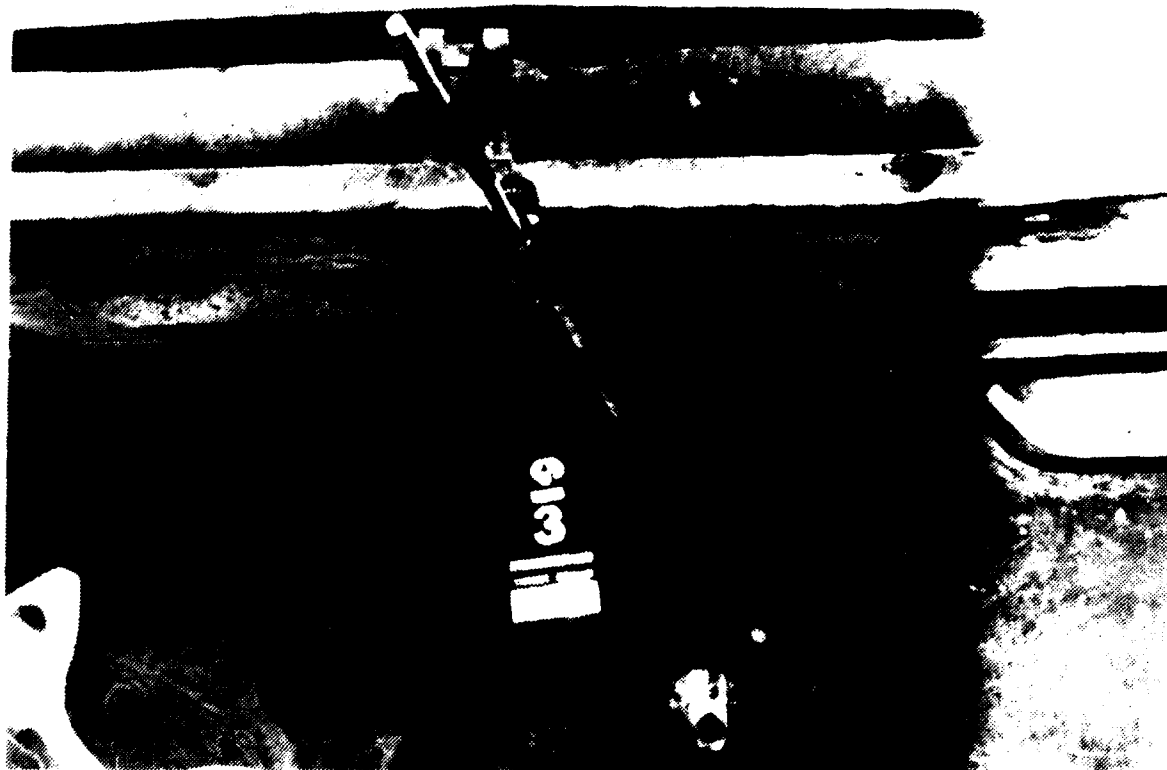
Impact 3 (Fig. 30) -- Spall from impact on the intermediate track cover perforated the right rear externally mounted fuel cell causing a 100 percent loss of function to the fuel cell.

Fig 30. Impact 3, Mission 3, Target 18 Causing Spalling
Which Perforated the Right Rear Externally Mounted
Fuel Cell

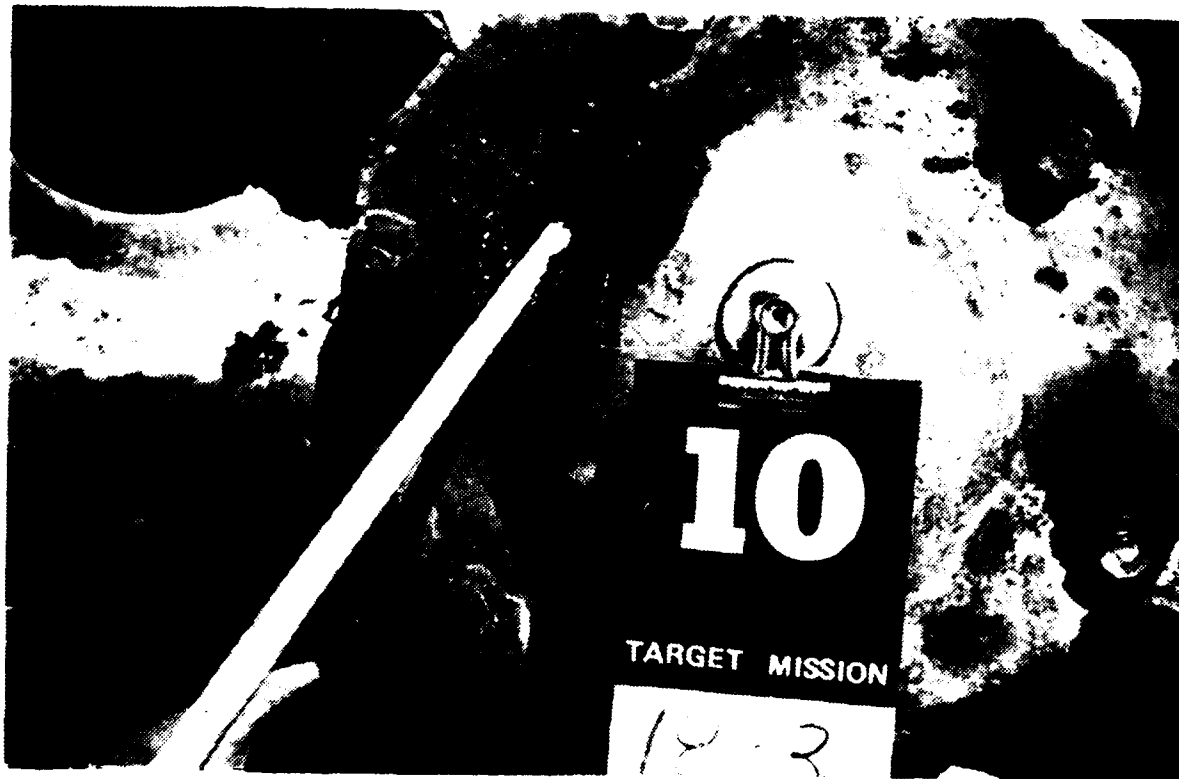
Fig 31. Impact 10, Mission 3, Target 18
Showing Damage to Right No. 1
Road Wheel

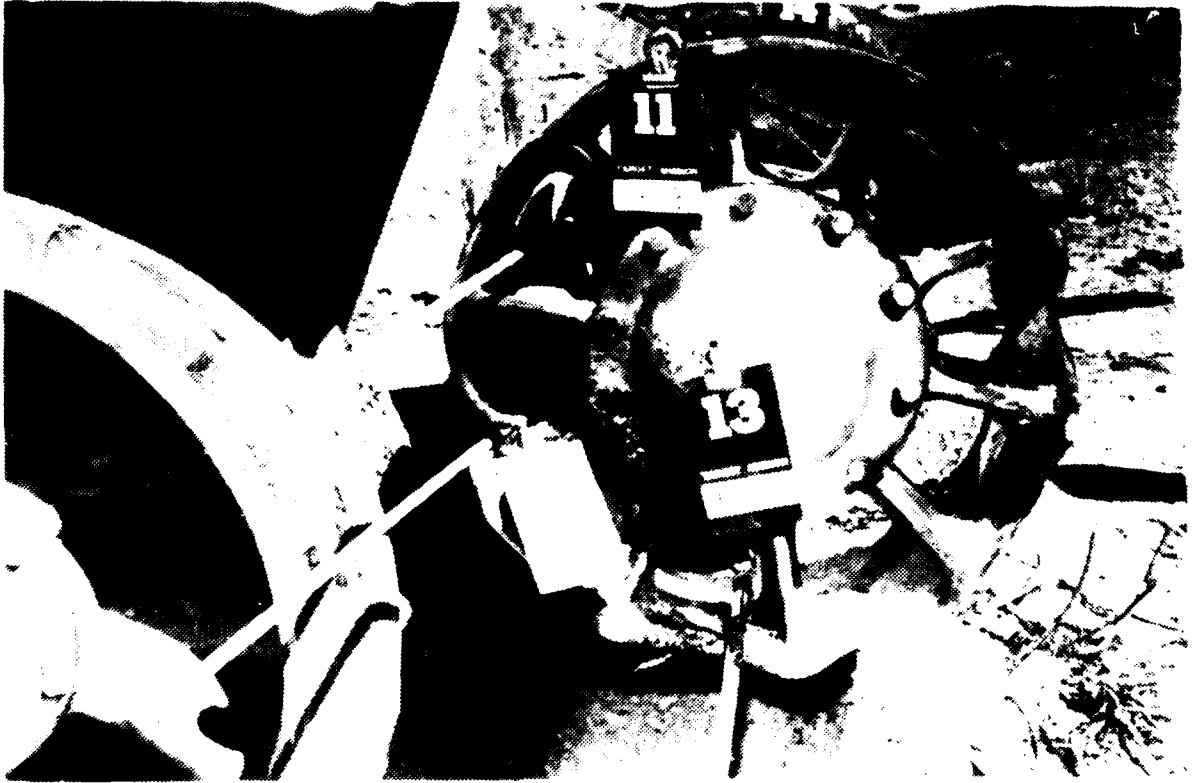
Impacts 11, 12, 13 and 14 (Fig. 32) -- Penetrated or damaged the right idler wheel. Impacts 11 and 13 both caused damage sufficient to result in a 100 percent loss of function to the idler wheel. Impact 12 split the idler wheel rim sufficiently to cause a 10 percent contribution to an M-Kill if considered alone. Impact 14 impacted the idler wheel rim causing negligible damage; however, the track was not in place. If the track had been in place it would have been damaged to an indeterminable extent.

Fig 32. Impacts 11, 12, 13 and 14 Showing
Damage to Right Idler Wheel
